Analysis of Power Quality Problems in Low-Voltage Circuits

H.R.P.M. de Oliveira, C.E.C. Figueiredo, *AES Sul*
N.C. de Jesus, E.L. Batista, *UNIJUI* and M. L. B. Martinez, UNIFEI

Abstract – This paper presents the analysis and the diagnosis of two cases with power quality problems in AES SUL’s commercial / residential customers, fed through low-voltage net. After a lot of monitoring of the customers’ feeding voltage, performed using specific equipment and a detailed and careful investigation, it was determined that the causes of the disturbances derived from the customers’ systems themselves. Then, the main steps used in the in the analysis and the results of the measurements that led to the identification of the problems are described.

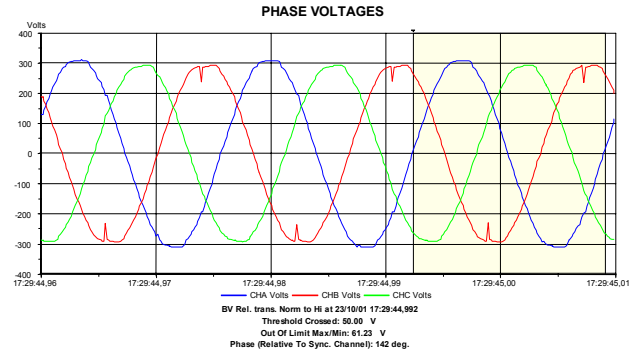
To evaluate the characteristics of the disturbances, the meter was connected to the point of common coupling of the consumer's low-voltage system, in compliance with the voltage wave shapes. Since the problems would occur rather frequently, the events related to the noises that damaged the consumer's recording system were registered already in the first measurements. Therefore, the data obtained during the monitoring with the Dranetz/BMI power platform PP 4300 is presented. By analyzing the results, one concludes that the notching-type events were probably responsible for the disturbances. Fig. 1 shows the voltages in a given moment when the problems occurred, as described by the consumer. One notes that only phase B was affected significantly, with typical characteristics of thyristors switching, deteriorating the voltage wave shape in each semi-cycle. After about 18 minutes, the consumer indicated the presence of the noises in his system again, but, at this moment, the disturbances in the wave shape occurred in phase A, as shown in Fig. 2. Thus, it was noted that the notching was related to the operation of non-linear single-phase loads connected to at least two phases of the three-phase system.

Fig. 1 Disturbances in phase B

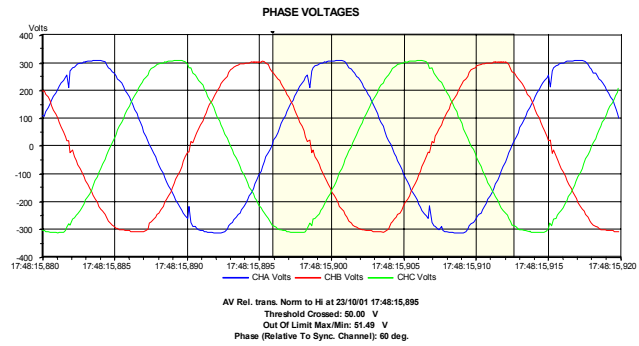
Fig. 2 Disturbances in phase A

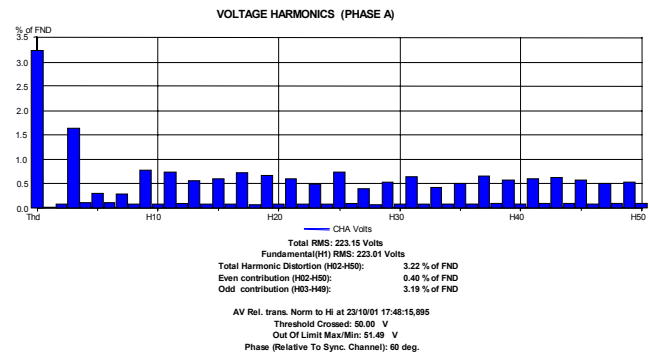
Fig. 3 shows the harmonic of phase A related to the cycle illustrated in Fig. 2. The prevalent harmonic refers to 3rd order (zero sequence), but there is the contribution of harmonic components in the whole spectrum, with low total harmonic distortion (THD) of 3.2%.

Fig. 3 Harmonic spectrum of phase A during the occurrence of the problems. Theoretically, the disturbances tend to be the more intense closer to the origin the monitoring is performed. Based on the first disturbances, a simultaneous measurement was carried out in the terminals of the transformer supplying the customer, and the results were compared. Figures 4 and 5, respectively, show the voltages in the transformer and in the consumer's during the interference problems. It is possible to note that the disturbances are more severe at the point of the complaining consumer than at the point of installation of the transformer. This fact helps to the extent that the probable disturbances were related to some load of the low-voltage network, characterizing as a case of origin internal to the consumer's facilities. The non-correspondence between the phases derives from the difference of sequences during the connection to the meter at the points of analysis.

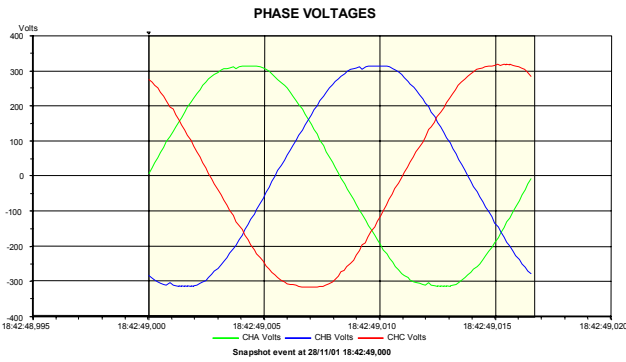
Fig. 4 Transformer Voltage

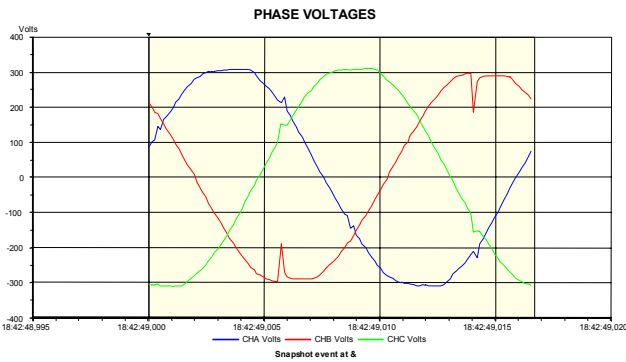
Fig. 5 Load voltage

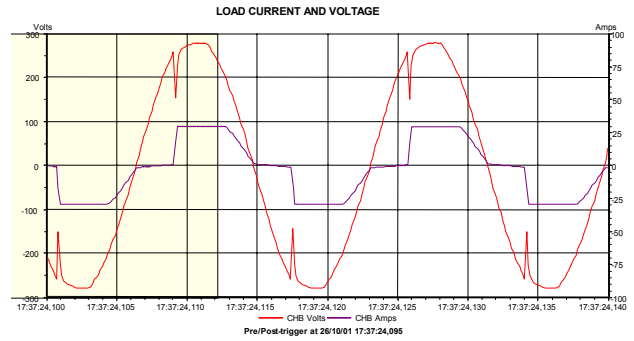
In a detailed survey of the main loads of the system, it was noted that there were electric showers with electronic temperature setting, that is, controlled by thyristors, in the complaining consumer's facilities, as well as in another consumer fed by the same low-voltage circuit and located electrically near the former. In this case, it was concluded that the operation of these loads, which usually present a rated power of 6 kW, was affecting the voltage wave and were directly related to the reported problems. Consequently, the consumer's shower feeding circuit current was monitored, and it was concluded that the currents of this load were significantly affecting the voltage wave, producing the noises in the consumer's system, which technically made the recording and reproduction of the final product impossible. Fig. 6 shows the record of the voltages and currents responsible for the disturbances (opposed polarities), thus resulting in the saturation of the current transformer of the metering instrument during the operation of the non-linear load of the complaining consumer himself, generating the noises in his audio system.

Fig. 6 Load current and voltage during disturbances

For tests of mitigation of the interference problems caused by the noises, the utility has purchased an isolation transformer with electrostatic shielding, which would feed the

notching-sensitive recording system. The results were not satisfactory and the noises continued disturbing the consumer. In this case, as an alternative, the use of an Uninterruptible Power Supply system or power conditioners to feed the consumer’s sensitive load [6] was recommended. The principle of functioning and equivalent power induces to a deterioration of the voltage wave, due to the operation of these loads. Concerning that, manufacturers are being contacted for clarifications as to other similar cases since, despite the improvement in terms of the electric shower operation (comfort and rationalization), it can cause severe problems and considerably damage the wave shapes of the voltages of the low-voltage systems.

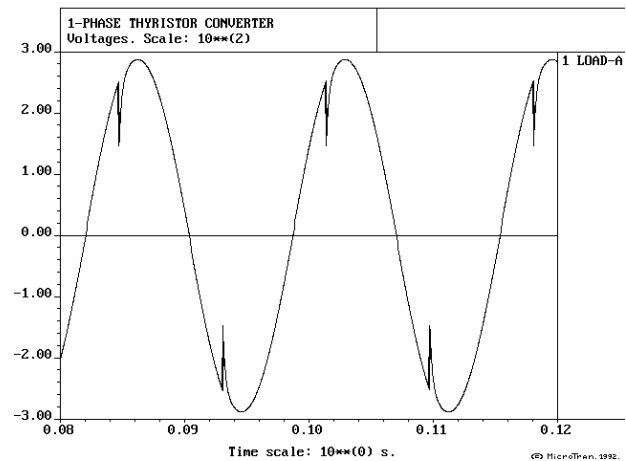
To evaluate the effect of the thyristor switching in such low-voltage system, the supplying electric system seen from the medium-voltage bus of the substation was modeled in the electromagnetic transients program Microtran, as showed in Figure 7, below. The controlled shower was represented by anti-parallel thyristors, operating with a fire angle of 60°. In Figure 8, one can note the voltage resulting from the non-linear load connection near the complaining consumer's facilities. The simulation results were very similar to those obtained during some measurements. Therefore, this new type of load, besides the specific problem generated, considerably affects the network voltages, which causes some concern due to its proliferation in the Brazilian market, making the attainment of the power quality and compliance of the voltage wave difficult.

Fig. 8 Load voltage simulation

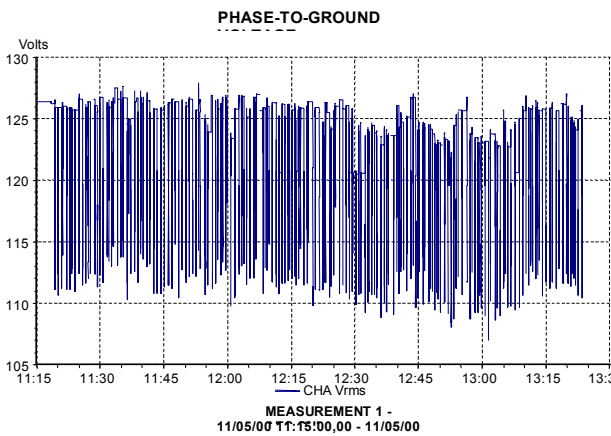
Since the problems were constant and almost permanent, the first measurement already indicated the variations disturbing the consumer’s operation. Fig. 9 shows phase-to-ground voltage measured at a point of the facility, used to supply power to computers. One notes the repeated variations in the wave shapes, significantly affecting the operation of the sensitive equipment available in the internal facilities.

During such period, there was an instant voltage sag of 15.75% below the rated value. Therefore, the disturbances are characterized as relatively intense events, besides having a very high frequency of occurrence. During some periods, the voltage variations would decrease, as reported by the consumer.

Fig. 9 Phase-to-ground voltage behavior

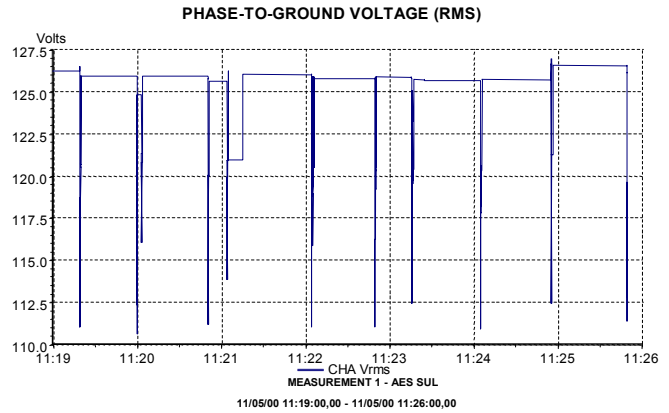
Fig. 10 shows a detail of the RMS variations, where one can note the characteristics and typical intervals between the disturbances. While Fig. 11 shows the voltage wave shape during one of the voltage sags occurred.

Fig. 10 Detail of voltage variations

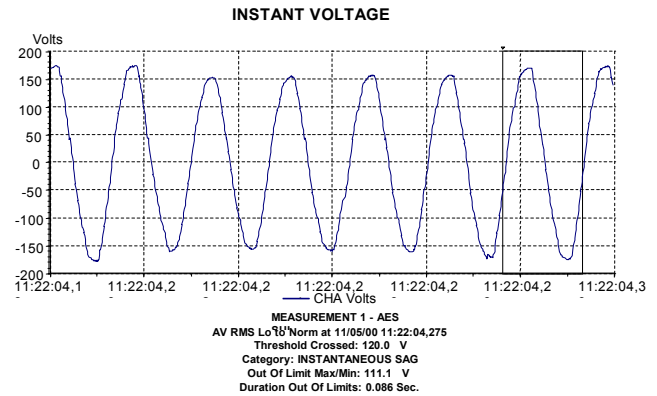
Fig. 11 Voltage sag

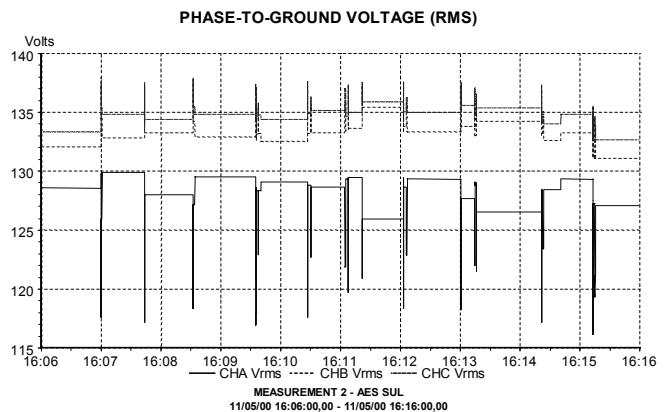
Fig. 12 shows the results of the measurement carried out at the consumer’s inlet during its normal operation, by obtaining the three-phase voltages. According to the previous results, phase A is the one presenting the most significant variations.

Fig. 12 Phase voltage behavior at the consumer’s inlet

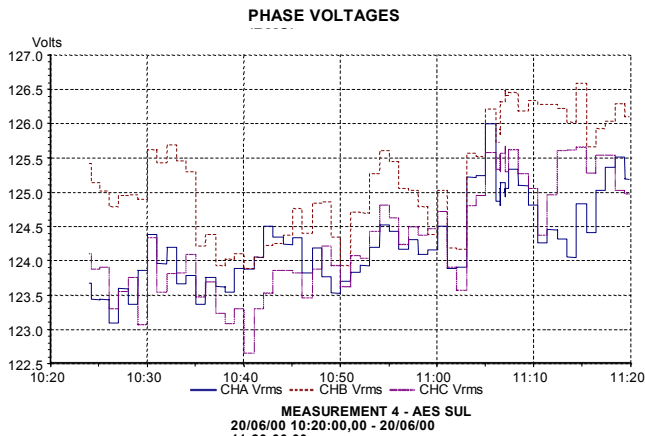
This measurement lasted approximately one hour and refers to a supply point existing right at the outlet of the transformer supplying the consumer. It must be stressed that the intensity and propagation of the disturbances depend on their location and on the monitoring point [2]. Figure 13 shows the RMS voltages in the terminals of the transformer of the distribution network, which presents a normal and basically balanced behavior. Therefore, an additional important indication that confirms the suspicion that the origin of this problem is also internal to the consumer.

Fig. 13 Transformer terminal voltages

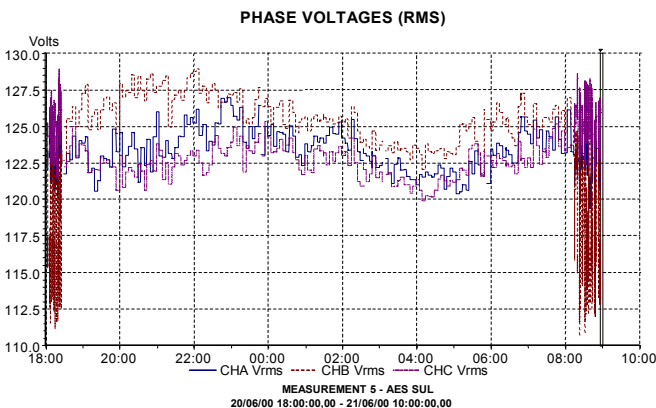
This measurement was performed at the inlet of the protection circuit breaker of the consumer and clearly shows that the disturbances occur only during the customer's regular working hours, indicating the consumer's operation under load as the cause. Fig. 14 illustrates the behavior of the voltages, which suffer the variations only during the business hours.

Fig. 14 Voltage behavior in consumer internal circuit

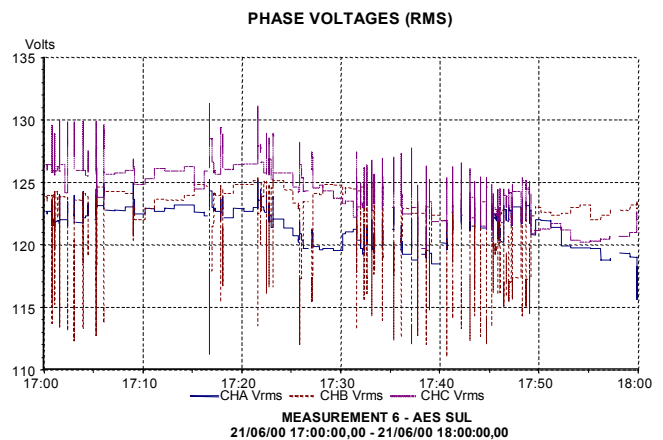
Figure 15 shows the RMS voltages obtained during this monitoring. As from 5.00 p.m., when several disturbances would occur, tests were done for a final check of the disturbing equipment. At 5.06 p.m., the breaker supplying power to the copier's circuit was opened, and the voltages returned to the normal condition. After approximately 10 minutes, the copier was connected again and the voltages presented significant variations once more. At this moment, it was defined that the cause of the disturbances was the bad functioning of the copier. So, at about 5.49 p.m., it was deenergized and the sequence of the voltage sags in one of the phases was interrupted again.

Due to the correct determination of the equipment responsible for the disturbances, it was proven that the cause of the voltage sags that generated the flicker phenomenon derived from the high currents requested during its inadequate operation, being characterized as a case of internal origin as well.

Fig. 15 Voltage behavior in the switchboard

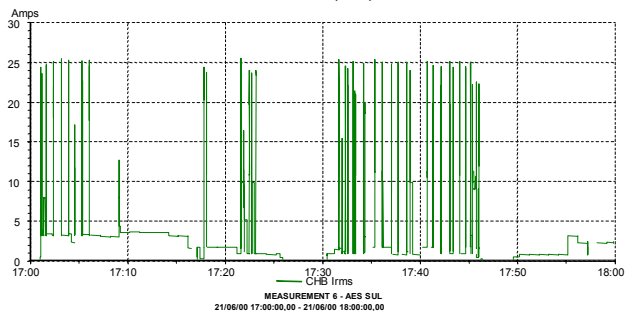
It must be stressed that current rises in the same phase during almost the whole period of this measurement were monitored, coinciding with the disturbance moments, as showed in Figure 16. Such copier, operating in the standby mode, requested around 0.5 [A], and suddenly drained an excessive current during some cycles, causing the short undervoltages. We highlight that the maximum values of the currents were not recorded by the measurement equipment due to the saturation of the current transformer. In this case, it is estimated that the peak values of the currents during the disturbances were higher than 50 [A].

Fig. 16 Phase current in the copier's supply circuit

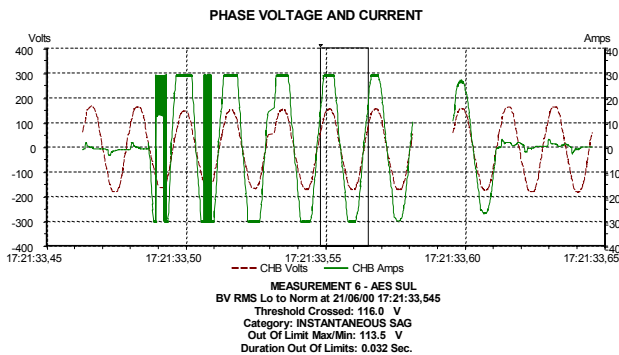
Fig. 17 shows, simultaneously, the voltages and currents during one of the events related to the flicker problems; therefore, as a result of the respective current rises.

Fig. 17 Phase voltage and current with disturbances
