Analysis of Power Quality Problems in Low-Voltage Circuits

H.R.P.M. de Oliveira, C.E.C. Figueiredo, *AES Sul*
N.C. de Jesus, E.L. Batista, *UNIJUI* and M. L. B. Martinez, UNIFEI

Abstract – This paper presents the analysis and the diagnosis of two cases with power quality problems in AES SUL’s commercial / residential customers, fed through low-voltage net. After a lot of monitoring of the customers’ feeding voltage, performed using specific equipment and a detailed and careful investigation, it was determined that the causes of the disturbances derived from the customers’ systems themselves. Then, the main steps used in the in the analysis and the results of the measurements that led to the identification of the problems are described.

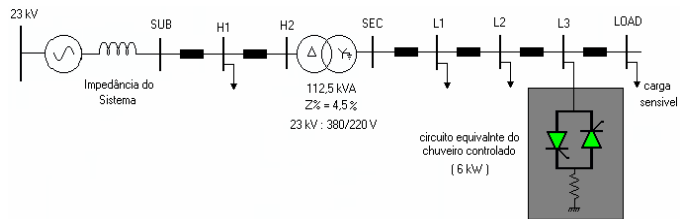
Fig.7 System's one-line diagram

To evaluate the effect of the thyristor switching in such low-voltage system, the supplying electric system seen from the medium-voltage bus of the substation was modeled in the electromagnetic transients program Microtran, as showed in Figure 7, below. The controlled shower was represented by anti-parallel thyristors, operating with a fire angle of 60°. In Figure 8, one can note the voltage resulting from the non-linear load connection near the complaining consumer's facilities. The simulation results were very similar to those obtained during some measurements. Therefore, this new type of load, besides the specific problem generated, considerably affects the network voltages, which causes some concern due to its proliferation in the Brazilian market, making the attainment of the power quality and compliance of the voltage wave difficult.
